Flood Control Project Maintenance
2008 Structure Summary Report
Overall Unit and Item Ratings

Sacramento Maintenance Yard

2008 Structure Inspection Results

Inspection Report - Structure 2008

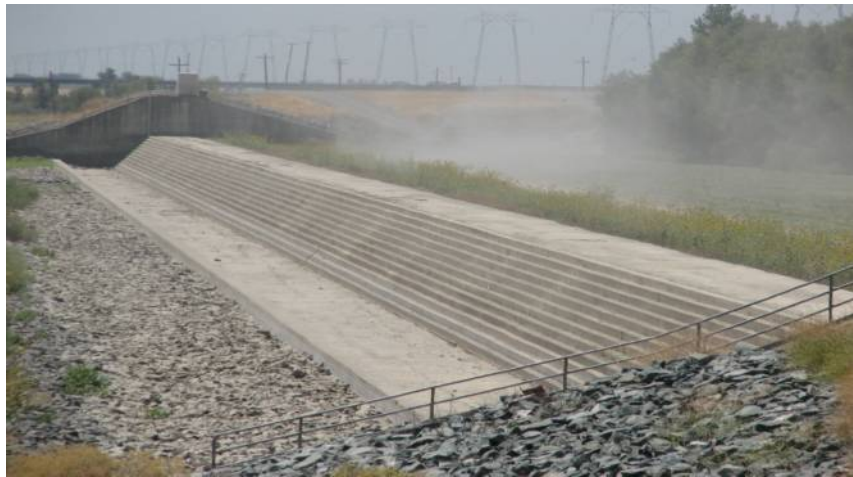
Report Line	4
Location	
Category	Structures & Concrete Lined Channels
Item	Concrete Surfaces
View of Cache Weir and stilling basin rip rap on north side GPS center of weir 38.68457 - 121.67326

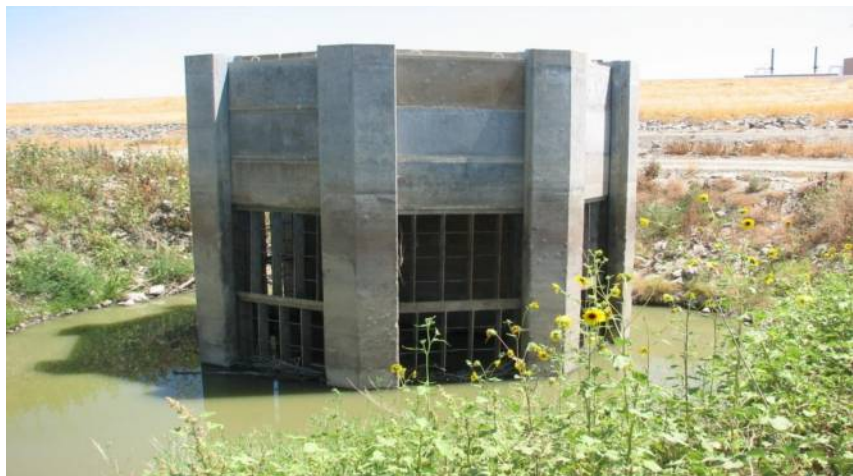
Report Line	4
Location	
Category	Structures & Concrete Lined Channels
Item	Concrete Surfaces
View of low flow inlet structure located southeast corner of settling basin closure gates upper right corner of picture GPS at gates on levee 38.67844 -121.67294

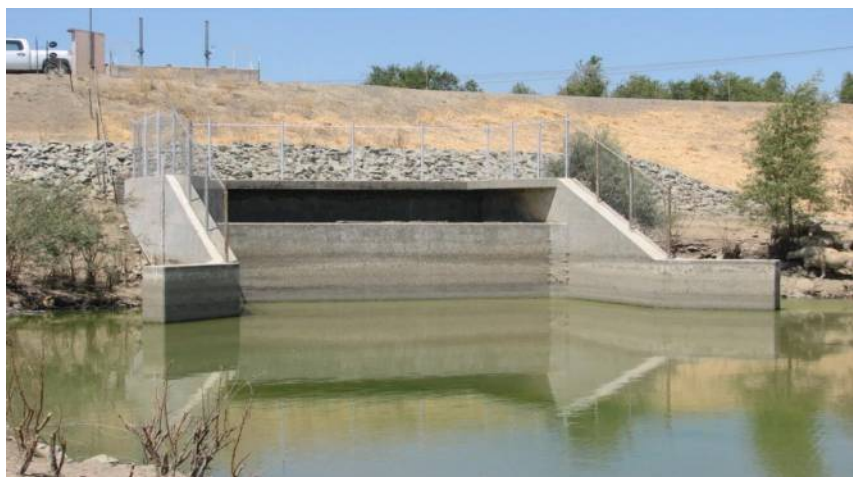
Report Line	4
Location	
Category	Structures & Concrete Lined Channels
Item	Concrete Surfaces
View of outlet of low flow channel

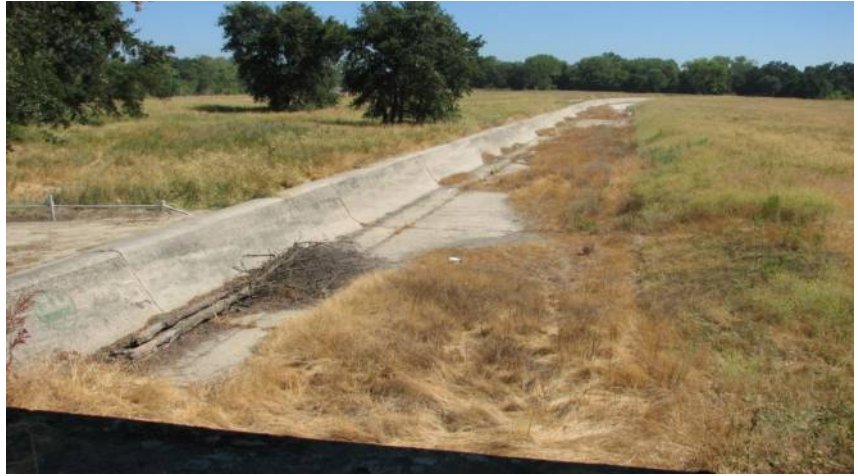
Report Line	3
Location	
Category	Structures & Concrete Lined Channels
Item	Concrete Surfaces

View of weir and stilling basin from abutment unit
1GPS 38.75907 -121.66541

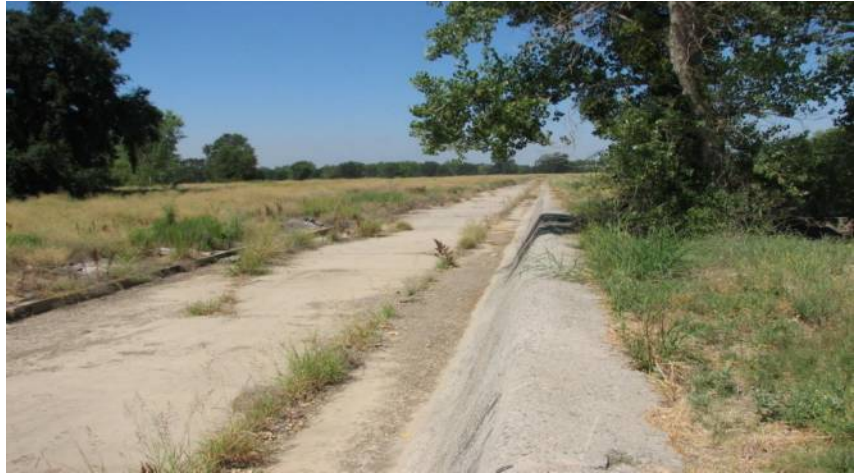
Report Line	3
Location	
Category	Structures & Concrete Lined Channels
Item	Concrete Surfaces

View from fish ladder looking west GPS
38.76424 -121.64689

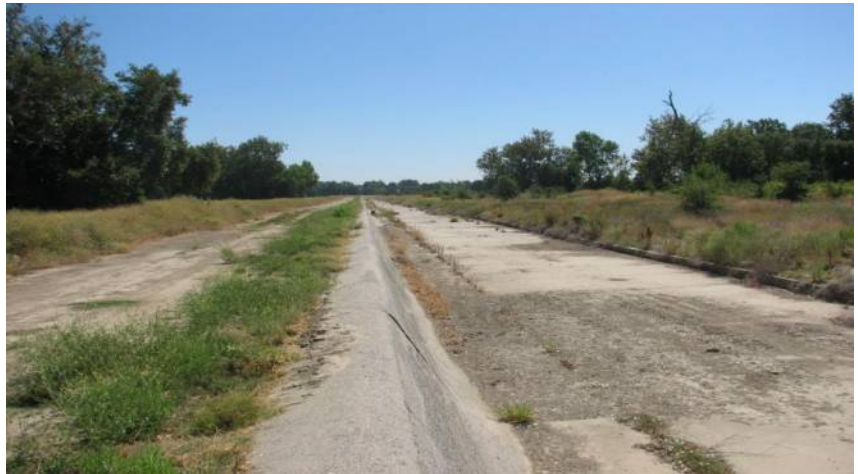
Report Line	3
Location	
Category	Structures & Concrete Lined Channels
Item	Concrete Surfaces

View from fish ladder looking east

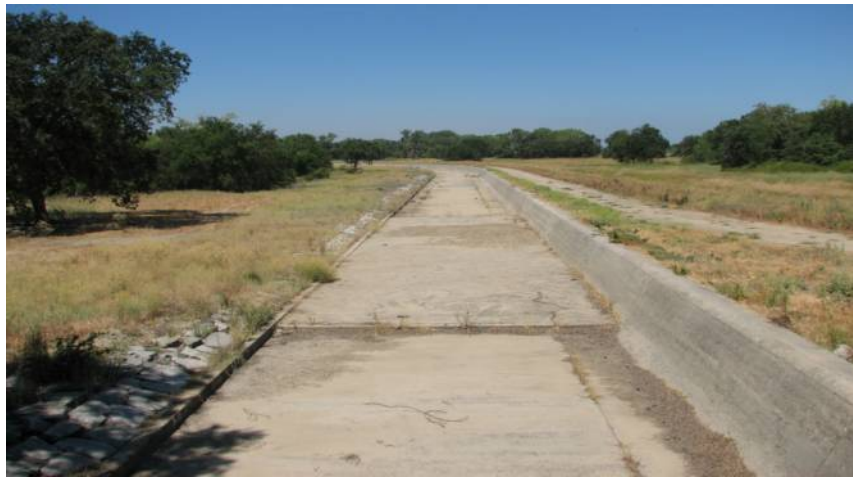
Report Line	3
Location	
Category	Structures & Concrete Lined Channels
Item	Concrete Surfaces

View looking west from abutment East Levee
Yolo Bypass

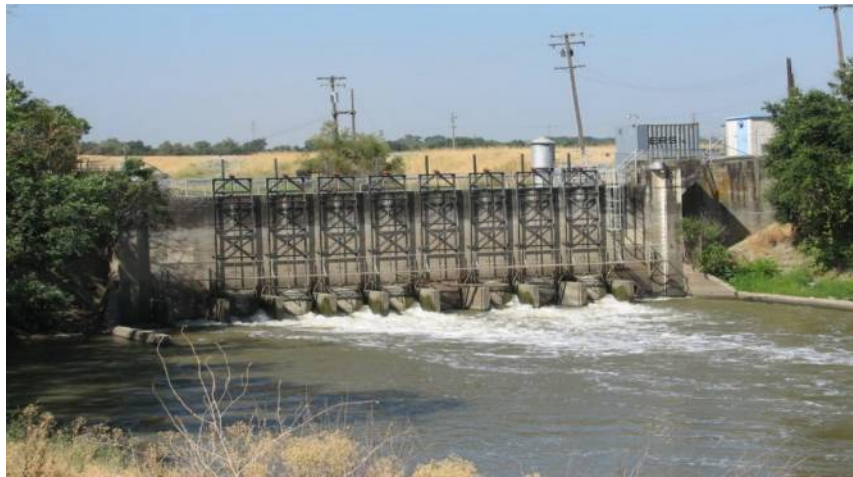
Report Line	3
Location	
Category	Structures & Concrete Lined Channels
Item	Flap Gates

Downstream side of the structure from right bank

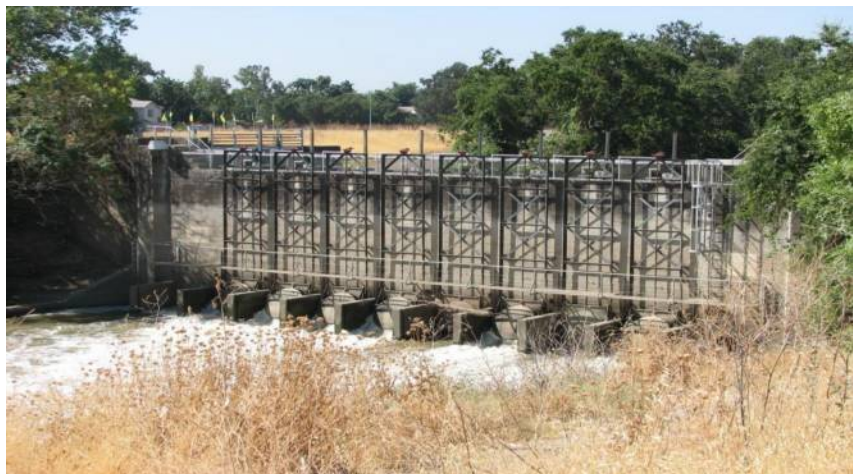
Report Line	3
Location	
Category	Structures & Concrete Lined Channels
Item	Flap Gates

Downstream side view from left bank

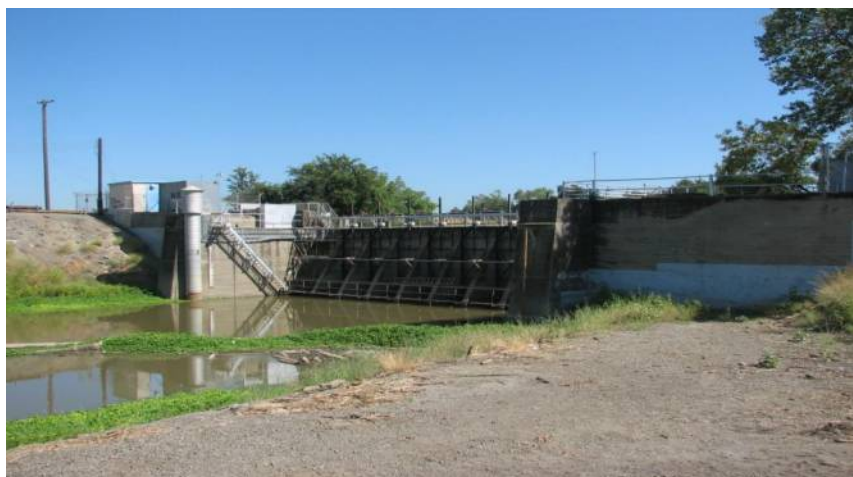
Report Line	11
Location	
Category	Structures & Concrete Lined Channels
Item	Trash Rakes

Upstream side of structure from right bank log boom in place

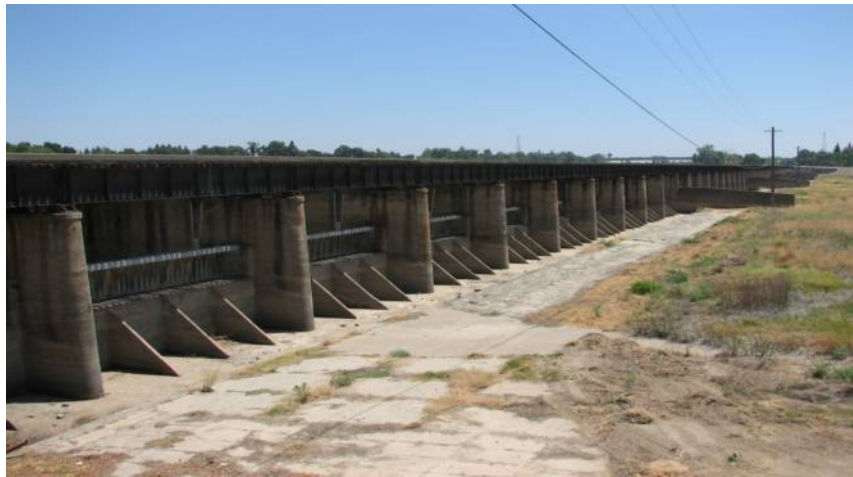
Report Line	3
Location	
Category	Structures & Concrete Lined Channels
Item	Concrete Surfaces

View of weir and stilling basin downstream side north end GPS 38.60718 -121.56005 center point
GPS 38.60466 -121.55733

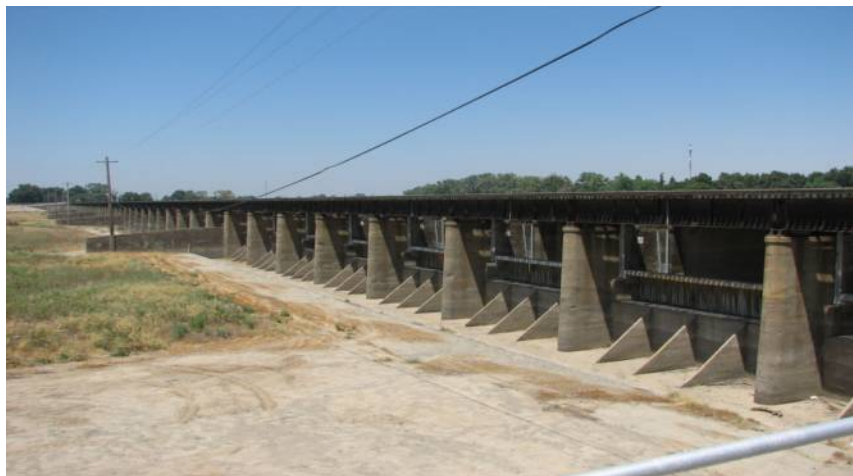
Report Line	3
Location	
Category	Structures & Concrete Lined Channels
Item	Concrete Surfaces

View of weir and stilling basin south end GPS 38.60281 -121.55577

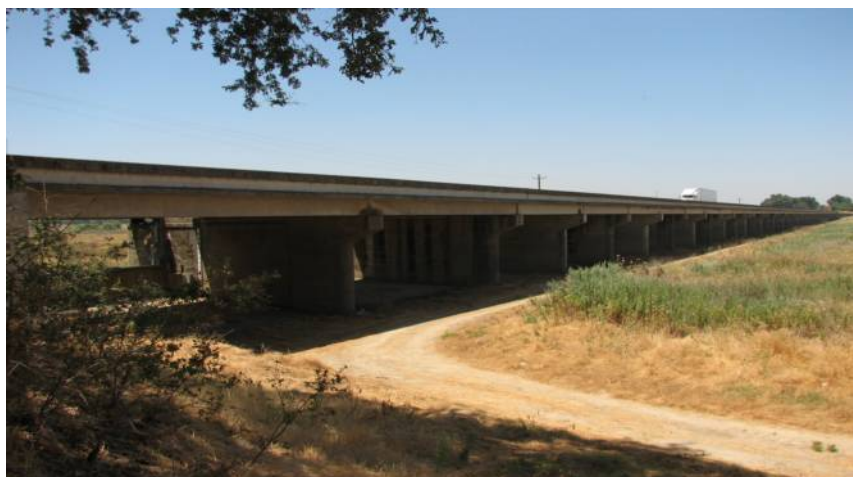
Report Line	3
Location	
Category	Structures & Concrete Lined Channels
Item	Concrete Surfaces

southend looking north upstream side of weir
